Picture Story

Sheared sheath of a stylet: Early detection avoiding disaster

Sri Lanka Journal of Child Health, 2022; **51**(1): 162

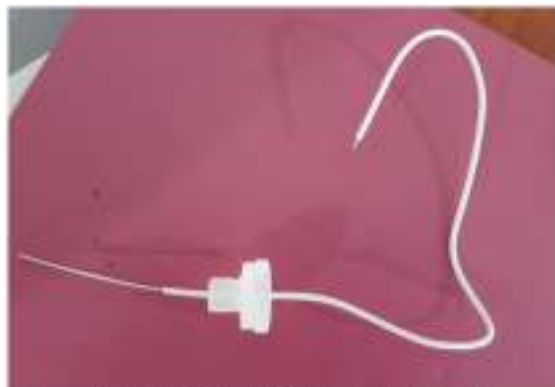
An emergency intubation with a 2.5 mm endotracheal tube was carried out on a neonate born at 25 weeks of gestation weighing 900g. A neonatal stylet with a plastic sheath was used. It was difficult to remove the stylet following intubation. It was noted that a piece of its sheath was missing when the stylet was removed (Figure 1). Endotracheal tube was removed and missing piece of the sheath was found inside the endotracheal tube (Figure 2)

Figure 1: Stylet with broken sheath

Sheared sheath is a potential complication with the use of stylets^{1,2}. Broken sheath would have lodged in the tracheobronchial tree if the baby was ventilated without detection leading to a potential lethal outcome. It is important to check for intact sheath following intubation.

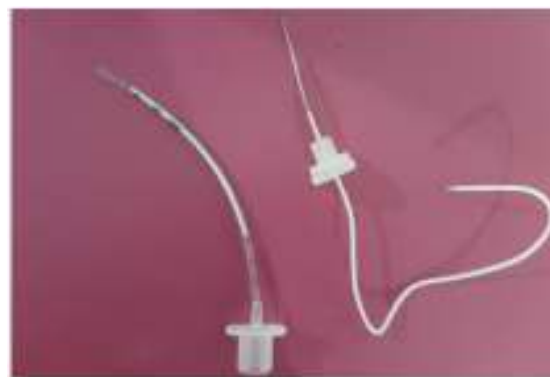
Figure 2: Broken sheath inside endotracheal tube and the stylet
